DIAGNOSES AND REPAIR OF A CRACK IN THE DRIFT TUBE LINAC ACCELERATING STRUCTURE AT LANSCE*

W. C. Barkley[†], D. A. Bingham, M. J. Borden, J. A. Burkhart, D. J. Evans,
 J. T. M. Lyles, J. P. Montross, J. F. O'Hara, B. J. Roller, M. Sanchez Barrueta
 Los Alamos National Laboratory, Los Alamos, NM, USA

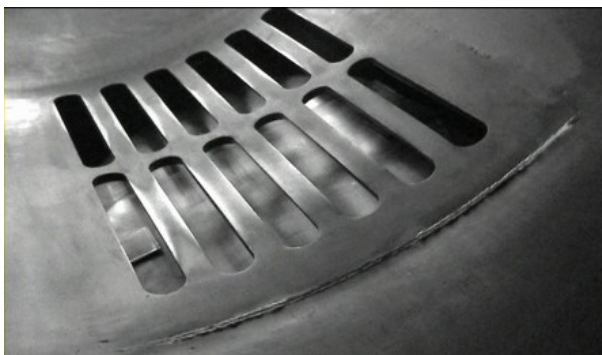
Since thorough cleaning, verifying window integrity and vacuum leak reduction did not affect the arcing, it was decided to shut down power, open up the vacuum system and look more closely at the module's copper surfaces with cameras. Although this task seems relatively simple and straightforward, it required the design and fabrication of special tooling to feed the cameras through the small ports and grates available to access the tank. A borescope was supplemented by a special, high-resolution camera, purchased specifically for the job. These cameras allowed close-up viewing and photography of geometric features that could be compared against previous photos to distinguish changes revealing the cause. After much time and effort, the RF Team discovered a crack in the ion pump grate at one of the transverse copper welds. The crack was approximately 30 cm long and 3 mm wide (Fig. 2). This feature was in the region identified by the x-ray detectors.

Figure 2: Crack in weld at ion pump grate.

Evidence collected during the investigation suggested that the crack was the source of the arcing issue but it was not entirely conclusive. Should irreversible damage occur during repair, the mission of LANSCE would suffer, potentially adversely affecting the next run cycle and perhaps beyond. Therefore, the conservative approach had to be a graded one in which the most unintrusive solutions would be tried first.

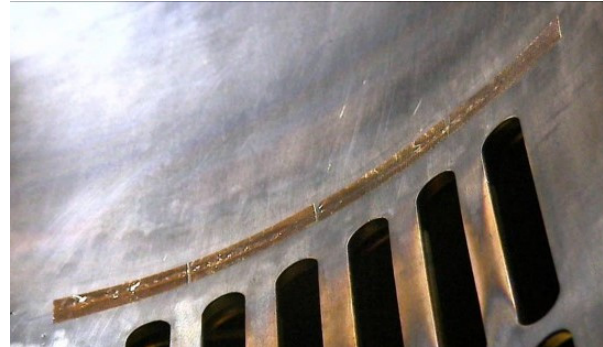
vacuum pumping and leak checking were performed each time a different approach was tried, a resource intensive operation. The copper tape succeeded to a point in the RF power ramp (RF average power: 7.2 kW of 160 kW needed), then blistered and failed (Fig. 3). The advantage of this approach was that it confirmed the strong suspicion that the crack was the source of the issue.

Figure 3: Blistered copper tape.

Copper foil tape was selected based on its composition, conductive adhesive, and thickness (0.066 mm). The tape would be applied over the crack through the ion pump grate but would be visualized for integrity and coverage through one of the frequency tuner ports. Reassembling, cleaning,

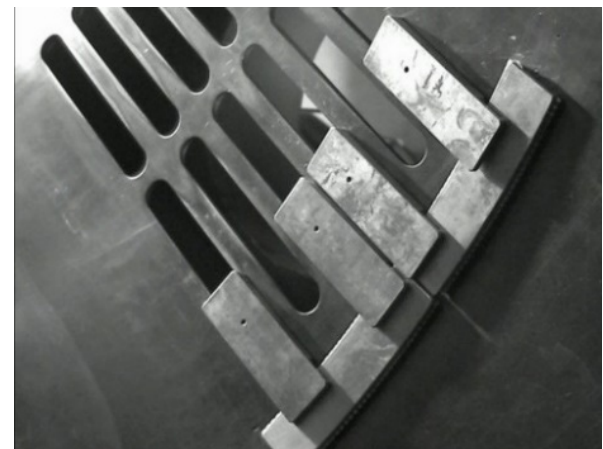
Figure 5: Clamped bridge.

A clamped bridge to cover the crack would be tried next (Figs. 4 and 5). In this design, the piece that makes contact with the tank wall would have Ag plated Be-Cu finger stock brazed onto it so that good electrical contact could be obtained while allowing the RF induced current to flow up and over the clamps and bridge. Outgassing of the crack would be preserved due to the gaps and open ends. Although careful thought went into design and implementation of the clamped bridge, it also failed to control arcing (RF average power: 134 kW of 160 kW needed). However, the improvement confirmed that this small crack was the source of breakdowns.

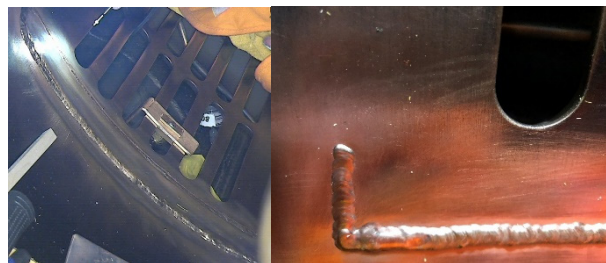
After several tank entries, a patch on the crack was successfully welded but this caused an additional perpendicular crack to open up from heat-induced stress (Fig. 6). Welding parameters for patch: current - 250 A, wire speed - 3.7 m/min, Argon shield gas.

Figure 6: Welded patch (left) and heat induced crack (right).

The heat induced crack was also welded (160 A, 2.3 m/min) with better relief this time so new cracks did not occur. Three entries into the tank over a period of two weeks added up to a total of 8 hours to complete the repair. This effort restored the module to normal operating values of 260 kW average power at 120 Hz repetition rate.
