Diagnoses and Repair of a Crack in the Drift Tube LINAC Accelerating Structure at LANSCE

Walter Barkley Mechanical Engineering

AOT-MDE

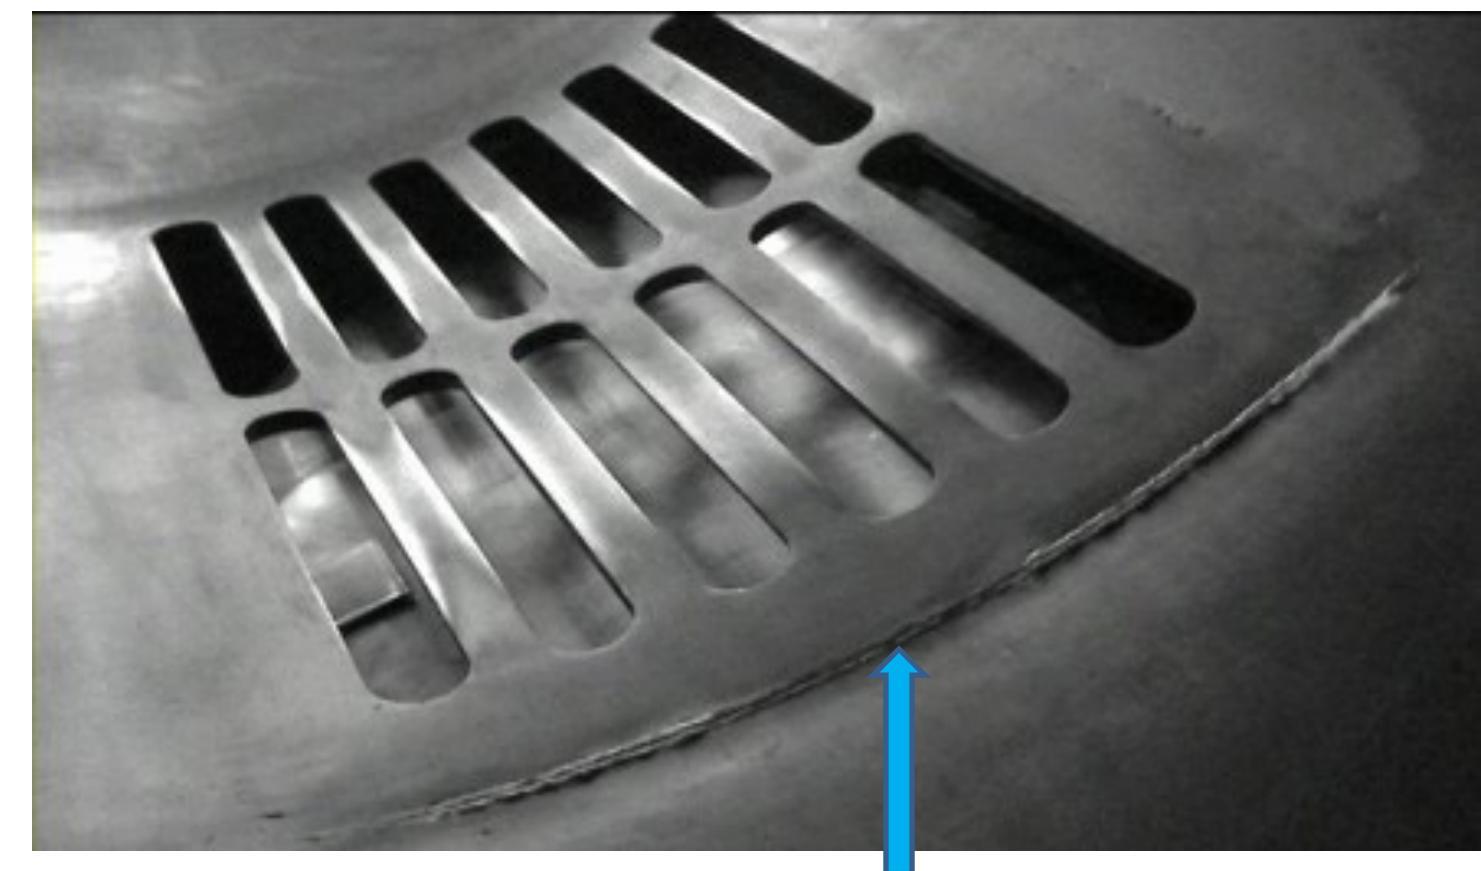
A borescope was supplemented by a special, highresolution camera. purchased specifically for the job. These cameras allowed close-up viewing and photography of geometric features that could be compared against previous photos to distinguish changes revealing the cause.

After a careful and systematic effort, the 201 RF Team was able to find the likely cause of arcing; a crack (approximately 30 cm long and 3 mm wide) in the ion pump grate at one of the transverse copper welds.

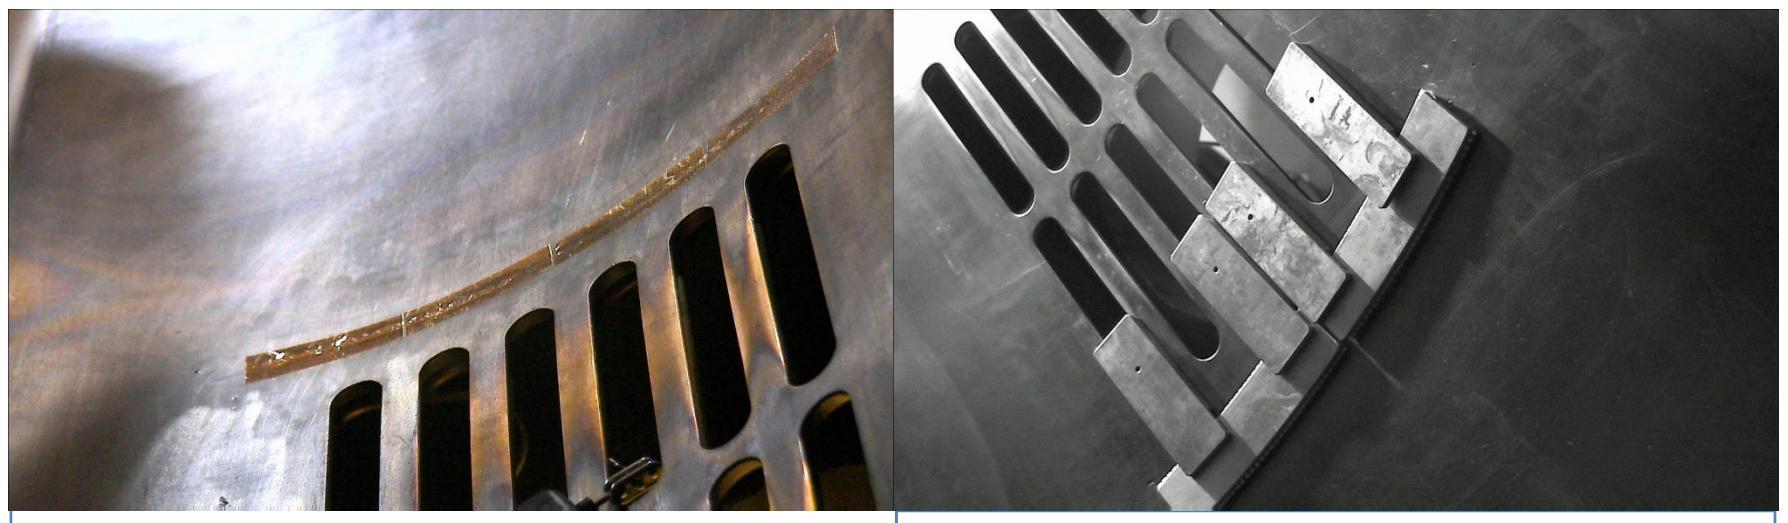
Copper foil tape applied to crack

This option was tried first and, by the behavior witnessed in the RF power, proved that the source of the issue was indeed the crack. Tape blistered when the power was ramped up proving this option not viable.

Copper bridge covering the crack

This option was installed but was not successful in preventing arcing and multi-packing
