ACCELERATED LIFETIME TEST OF THE SRF DRESSED CAVITY/TUNER SYSTEM FOR LCLS II HE PROJECT*

Y. Pischnalnikov[†], T. Arkan, C. Contreras-Martinez, B. Hartsell,
 J. Kaluzny, R. Pilipenko, J.C. Yun, Fermilab, Batavia, IL, USA
 W. Lahmadi, Phytron, Waltham, MA, USA

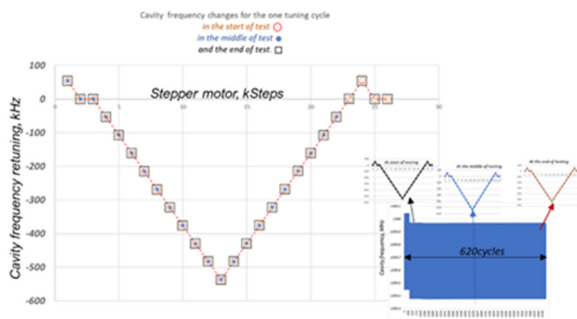
Figure 1: Cavity frequency changes for one full cycle (660kSteps) at the start, in the middle and end of test. No changes in cavity frequency tuning trend had been observed from start to the end of 626 cycles test (running tuner continuously for 2 month).

All the data collected during 2-month HTS test (cavity frequency vs time) presented on the Figure 1. There are 2 distinct portions: operation at T=4K (at the beginning of test) and T=2K. Figure 1 demonstrated fact that stepper motor actuators (and whole tuner) do not experience any loss of performances after operating in cold/insulated vacuum environment for 414 MSteps that equivalent to 2 lifetimes of LCLS-II-HE OFO. Three plots/cycles (at start, middle and end of test) of cavity frequency retuning vs tuner stroke/stepper motor stroke coincided with very good accuracy.

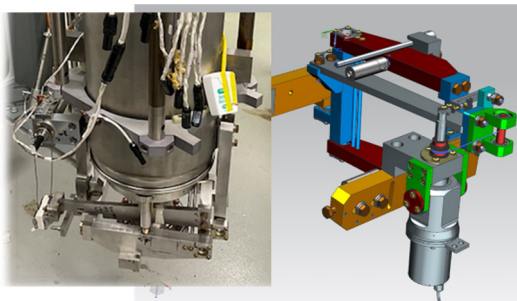
Figure 2: 3D model of the modified tuner. Picture of modified tuner mounted on the cavity before VTS test.

To demonstrate longevity of the dressed cavity bellow when compressed on 2.6mm (at T=2K) we need achieve ~2000. With tuner “as is” it will be required additional 4-5month of testing at HTS that could be difficult to accomplish for many reasons. We modify tuner to use steel cable that winding on the spool mounted on the Phytron shaft to compress cavity (Figure 2). This modification allowed to decrease time for one cycle (with compression 2.6mm) in approximately 40 times compare with operation at HTS. Dressed cavity with “modified” tuner has been installed into VTS. There were no issues with overheating stepper motor when it is submerged into liquid helium. Operation of the tuner monitored by reading frequency of the cavity. During one day of operation at VTS (8-10 hours shift) modified tuner compressed cavity/below on ~200 cycles. In the end of each operational day cavity/bellow was warm up and inspection of the bellow (visual & pressure test) have been conducted. Dressed cavity/bellow system withstand without any failure of 1660 cycles (~8 lifetime) up to 2.6mm compression.

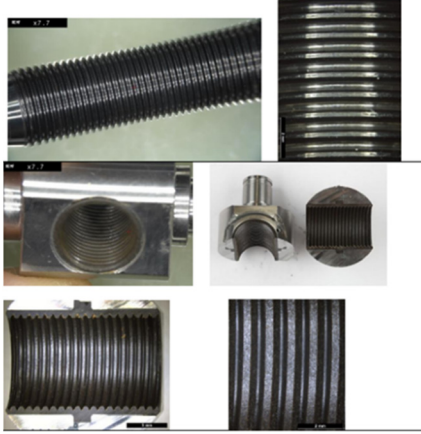
Figure 3: Pictures of Titanium shaft and TECASIN traveling nut. No visible wearing after 2-month longevity test.

Visual inspection of the stepper motor actuator has been performed after 2-month lifetime test at FNAL. During inspection (without dis-assembly of the actuator) main attention has been paid to spindle and traveling nut. Previous experience with longevity studies of different type of stepper actuator predicted that it could be most likely components of the actuators that could failed. We were not able to see any significant degradations (Figure 3).

Investigation demonstrated that some components show no wearing (Figures 3, 4) when other revealed some wear. Ball bearing show signs of wear and failure of the adhesion of dry lubricant (DL-5 coating) (Figure 5). During accelerated test at FNAL operation of the actuator exceed 40-50 times design specification. Phytron experts concluded that actuator has experienced a higher stress as it designed for and is still in good working condition.

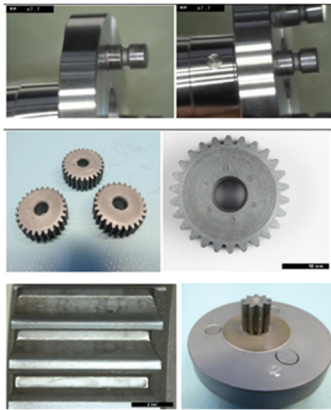
Figure 4: The second stage of gear box did not show significant damage.

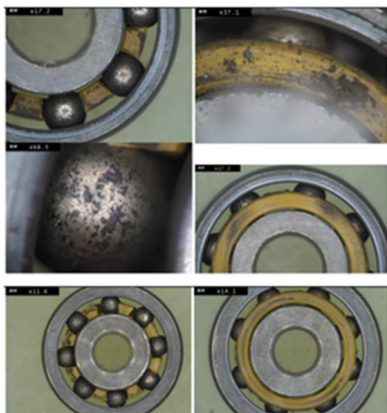
Figure 5: Ball bearing show signs of wear and failure of the adhesion of dry lubricant (DL-5 coating).
