Diagnoses and Repair of a Crack in the Drift Tube LINAC Accelerating Structure at LANSCE

Walter Barkley Mechanical Engineering

AOT-MDE

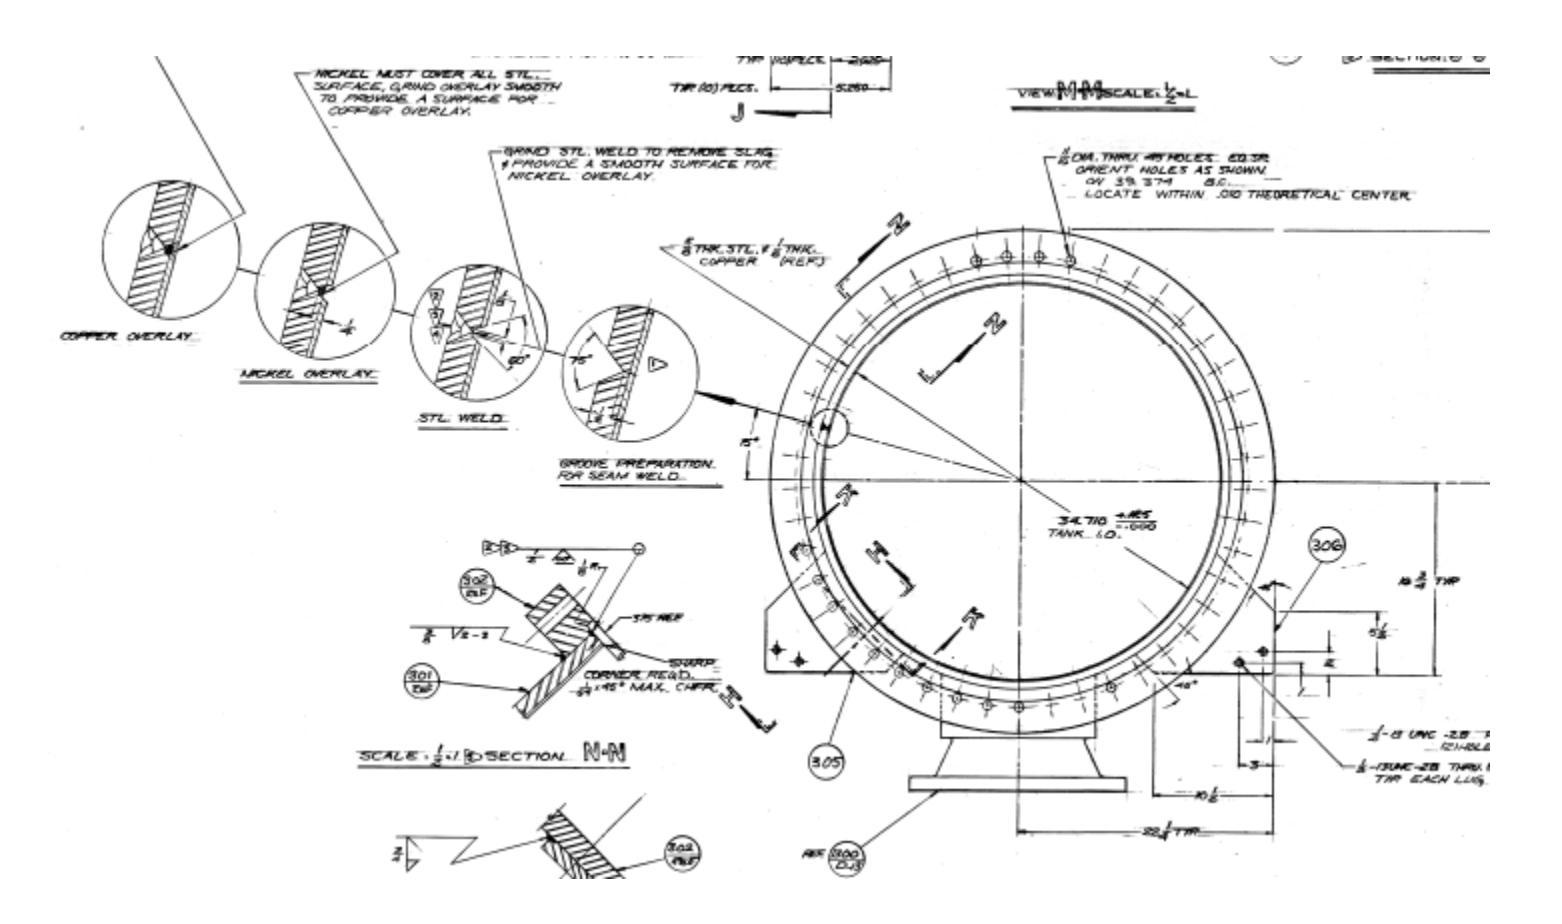
LANSCE Drift Tube LINAC (DTL) – Design Features

- Tank Inside Diameter 0.88 m
- Clad inner wall: Steel 15.9 mm thick, Copper 3.2 mm thick

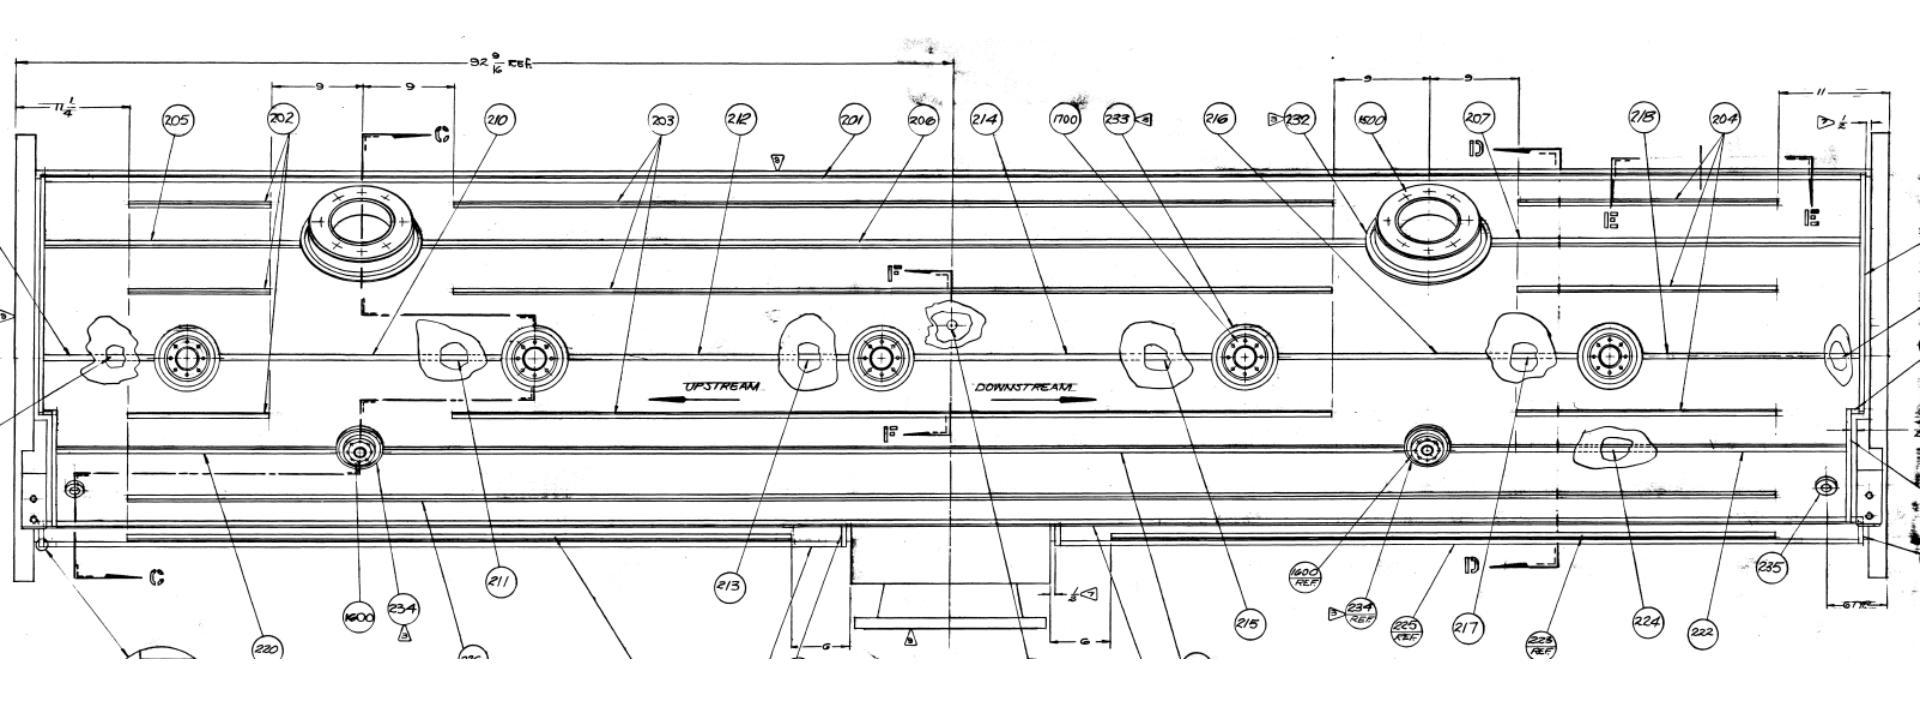
LANSCE Drift Tube LINAC (DTL) – Design Features

- Ribs for cooling water channels
- Ion pump ports: 30.5 X 44.5 cm rectangular (12 X 17.5 in)
- Frequency tuner ports: 16.2 cm ID (6.375 in)
- Post coupler ports: 5.7 cm ID (2.25 in)

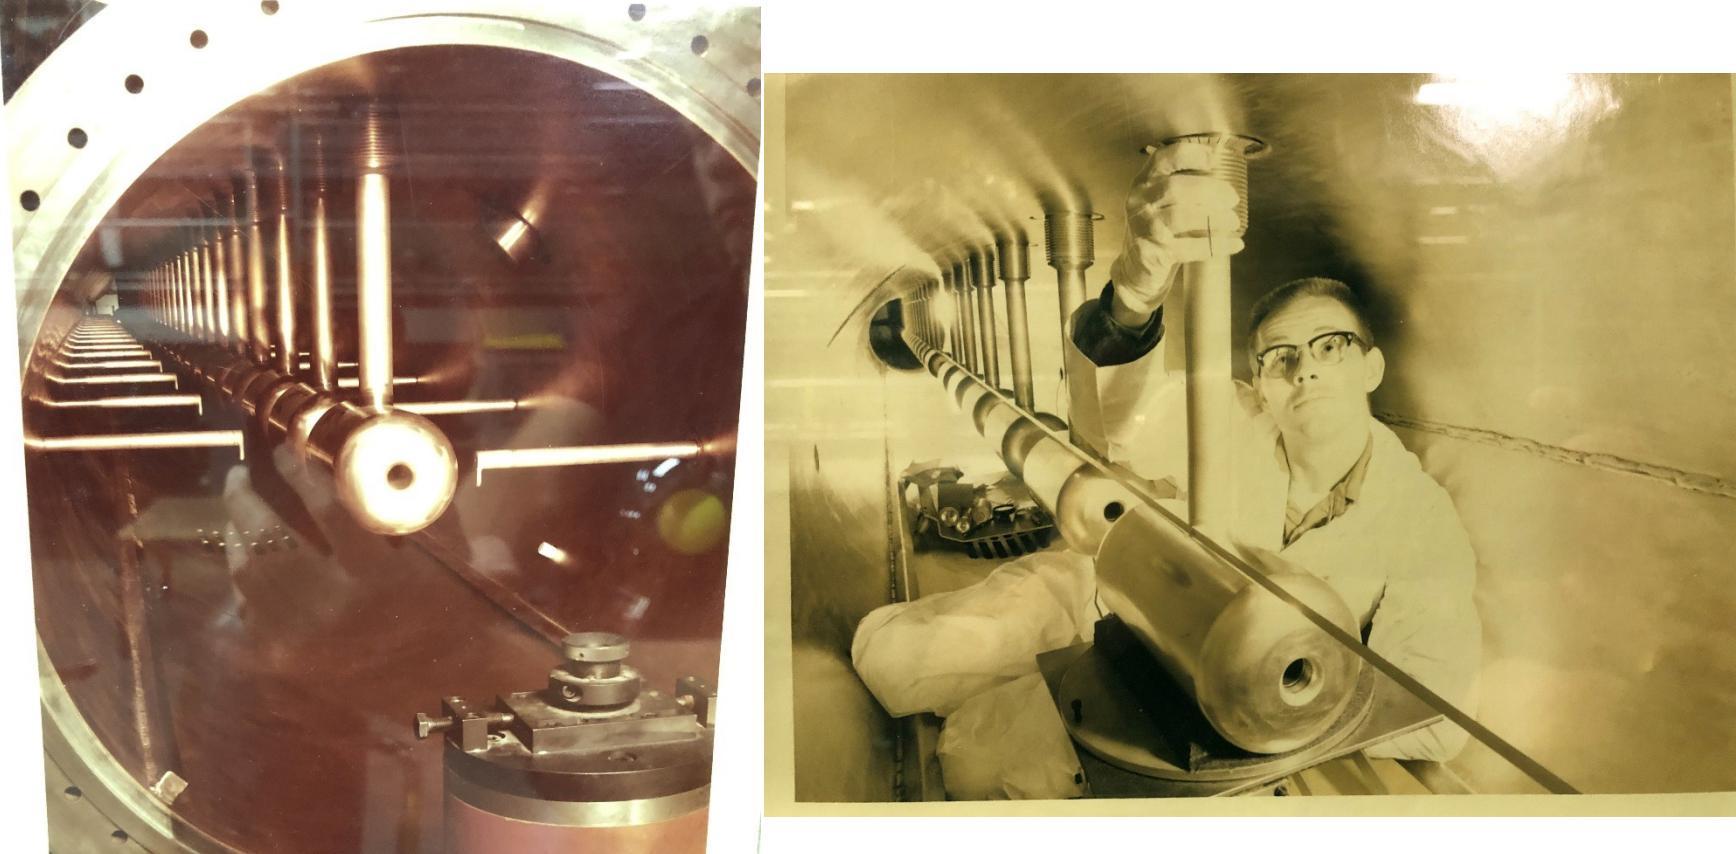
Photos from Original Build

Drift tube installation

Inside of tank - drift tubes and post couplers
